## BALTIMORE CITY--COMMISSION FOR HISTORICAL AND ARCHITECTURAL PRESERVATION

CDBG SURVEY YEAR: N/A AREA: Sandtown-Winchester SURVEY NO.: B-4227 MAGI NO.: 0442275604

ADDRESS: 1529-1533 North Gilmor Street

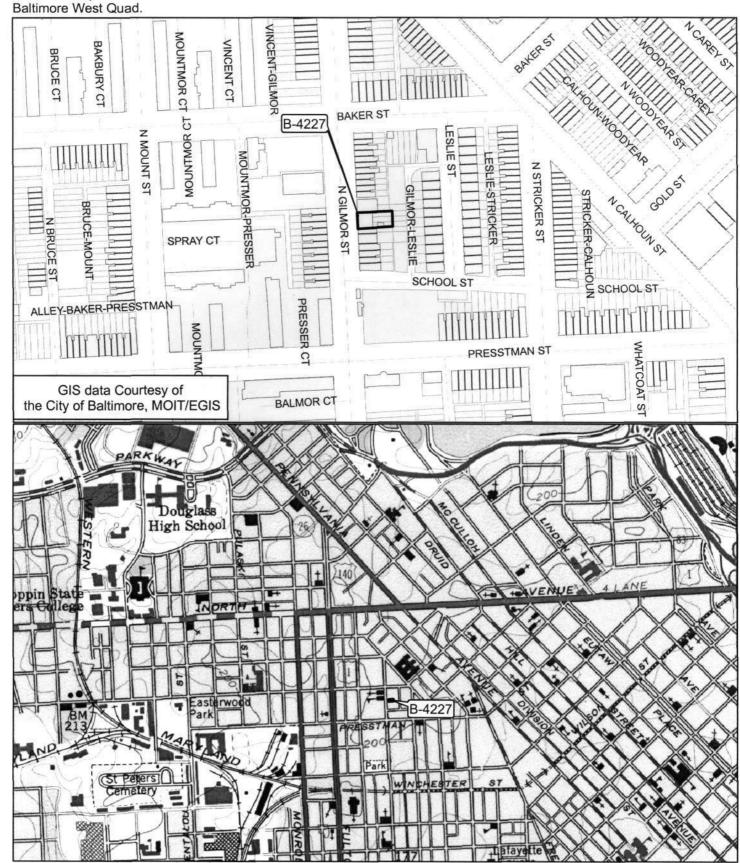
B-4227 1529-1533 N. Gilmor Street Block 0023 Baltimore City

The three adjoining rowhouses are three stories high and located in the middle of a block of two-story rowhouses on the east side of Gilmor Street. The brick facades are covered with Formstone, including the modest cornice line. It appears likely that a larger and more elaborate cornice had been removed prior to the application of artificial stone. The window and door openings are slightly arched. The first floor openings are boarded, and the upper stories in 1529 are boarded. The second and third stories of 1531 and 1533 display a variety of sash, mostly one-over-one, but also a six-over-six and a one-over-six. Brick steps replace the original marble steps at each entrance.

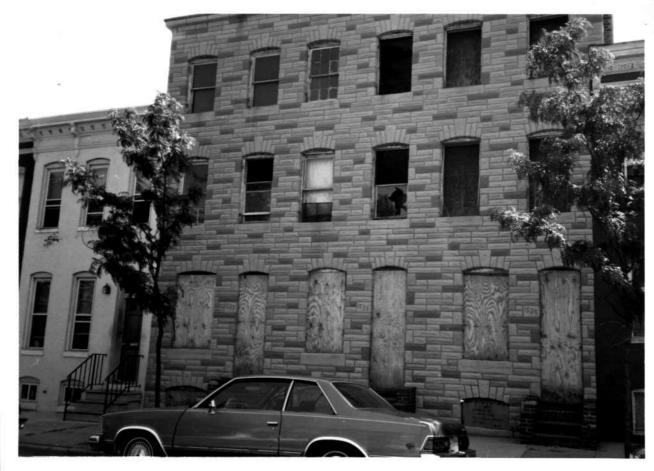
1529-1533 North Gilmor Street B-4227

West elevations
